# A Case Study of Contact Failure of Oil Temperature Sensor for Automotive Transmission

**Abstract:** In this study, we investigated the cause of the contact failure phenomenon of the oil temperature sensor whose signal error occurred intermittently during vehicle driving. The electrical contact failed sensor was disassembled and observed the contact surfaces with a scanning electron microscope (SEM). In the case of the present oil temperature sensor, the difference in thermal expansion coefficient of the male-female terminal and the vibration during driving cause fretting corrosion at the contact area. Fretting corrosion causes the signal error intermittently. It is judged that the lead wire composed of the flexible thin plate is structurally vulnerable to vibrations during driving, which further causes fretting of the contact point. Therefore, it is necessary to design an additional structural supplement to fix the flexible terminal of the sensor system.

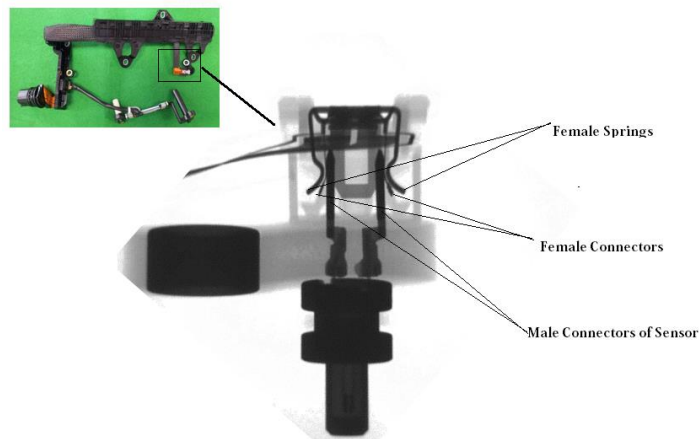
The effect of temperature change, which is the main cause of fretting in the present oil temperature sensor, was examined. As a result of confirming the structure of the oil temperature sensor system, as shown in Fig. 1, there is a possibility of fretting displacement due to difference of thermal expansion of material. The female terminal contact is a polymer with tin coating and the male terminal contact is made of brass with tin plating. The thermal expansion coefficient of the two materials is large. The coefficient of thermal expansion ( $\alpha$ ) is about  $8 \times 10^{-5}$  for polymer and about  $2 \times 10^{-5}$  for brass [6]. The polymer was assumed to be a pure polymer due to its thin coating of tin. The temperature difference is assumed to be  $70^\circ\text{C}$ , considering the winter season, if the maximum operating temperature of the transmission oil is assumed to be  $60^\circ\text{C}$ . The dimensions of the male-female terminal contacts are shown in Fig. 2. In this case, the length of the female terminal is 6 mm, and the total length of the contact part from the middle branching point to both ends is about 8.5 mm. If the temperature difference ( $\Delta T$ ) is  $70^\circ\text{C}$ , the length ( $l_o$ ) is 8.5 mm, and the thermal expansion coefficient ( $\alpha$ ) is  $8 \times 10^{-5}$ , the final thermal expansion length ( $\Delta l = \alpha \Delta T l_o$ ) is  $47.6 \mu\text{m}$ . The length ( $l_o$ ) of the male terminal is 3 mm and the final thermal expansion length ( $\Delta l$ ) is  $4.2 \mu\text{m}$  at the same temperature condition. The relative displacement due to thermal expansion of the male-female terminal contact corresponds to  $43.4 \mu\text{m}$ . Therefore, it is possible to cause fretting due to a full temperature change.

Fig 1: Transmission oil temperature sensor and its connector system

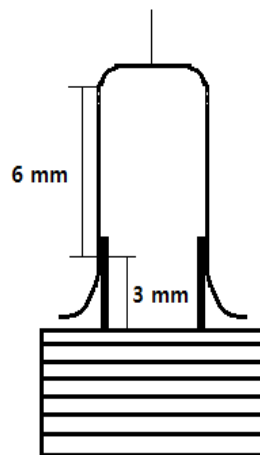
Fig 2: Dimensions and contact area of the female and male terminals

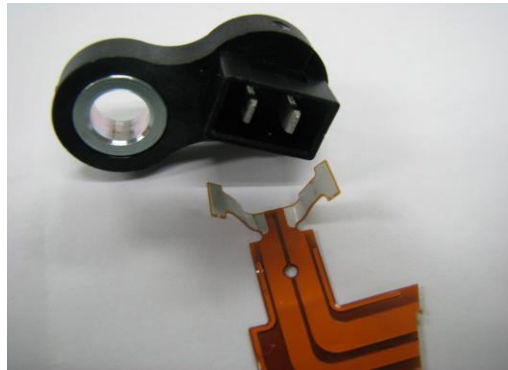
**Fig 3: Male and female terminals of the oil sensor for SEM observation**

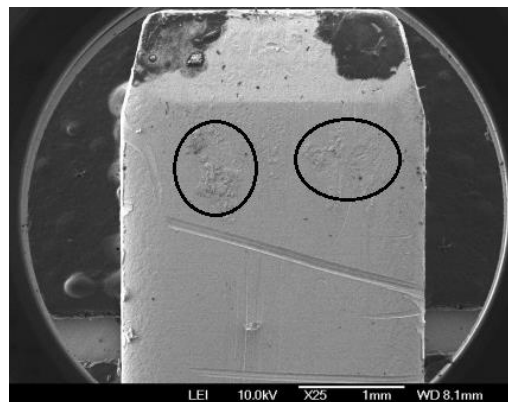
On the other hand, the contact point of the terminal which has a failure was observed by using a scanning electron microscope. The sensor was disassembled, as shown in Fig. 3. Fig. 4 is a photograph taken by a surface corresponding to the male terminal contact area. From the SEM microscope, as shown in Fig. 4, a slightly rough surface indicated by a circle of the male terminal is judged as the real contact area. That is, it was observed that the contact was not made in a wide part but only in some projections. For this reason, it is judged that the contact load is dispersed in two places because the shape of the spring that gives the contact load of the female terminal is slit in the middle. A slight scratch in the vertical direction of the lower part is judged as a scratch in the insertion or removal process.

**Fig 4: Surface of the fretting corroded male terminal**

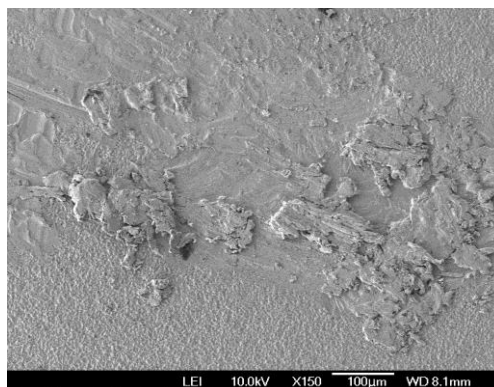
Fig. 5 is the magnified the surface of the fretting corroded male terminal in Fig. 4, showing that the tin oxide, which caused the fretting corrosion phenomenon, is accumulated on the surfaces. As a result, it is judged that an abnormal signal is generated due to an increase in contact resistance. Another male terminal was also observed to have slightly accumulated oxide layers in the middle. In the case of a tin-plated connector where fretting corrosion phenomenon occurs, it is common that small tin oxide debris is scattered on the terminal surfaces. However, small oxide debris was not observed on the oil temperature sensor terminal. It is presumed that the oil mist in the automatic transmission suppresses oxidization of the terminal surface.

**Fig 5: Magnified the surface of the fretting corroded male terminal in Fig. 4.**

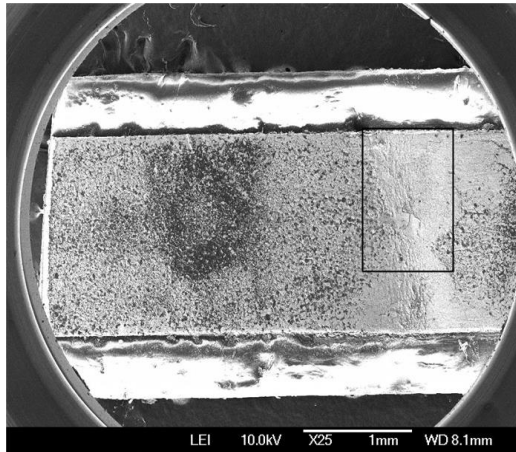
Fig. 6 is the surface for the flexible part of the female terminal, where the smooth part of the right region of the picture is actually bent so that it is in contact with the male contact part. Fig. 7 shows the magnified surface of the fretting corroded flexible female terminal in Fig. 6. From Fig. 7, the width of contact with the male terminal was observed to be more than 100  $\mu\text{m}$ . This distance is greater than 49.8  $\mu\text{m}$  due to pure thermal expansion. This fact suggests that there are other factors that cause other movements such as vibration in addition to thermal expansion. In the case of the present oil temperature sensor system, it is judged that the lead wire composed of the flexible thin plate is structurally vulnerable to vibrations during driving, which further causes fretting of the contact point. In addition, it was observed that a relatively small accumulation of oxides was observed in the female terminal as compared to the male terminal. The non-contact region is covered with small projections, as shown in Fig. 8. The original coat is a slightly silvery color when observed with the naked eye. However, after fretting corrosion, the contact area changes to a slightly blackish coating.

Fig 6: Surface of the fretting corroded flexible female terminal

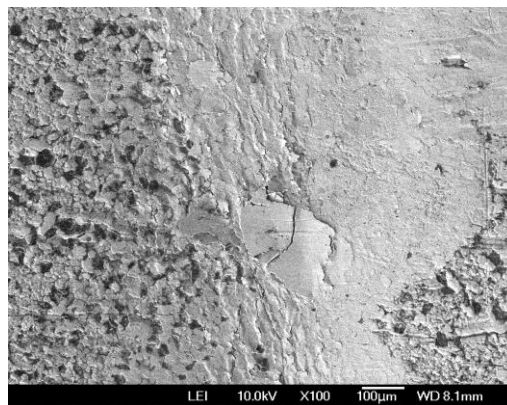
Fig 7: Magnified the surface of the fretting corroded flexible female terminal in Fig. 6

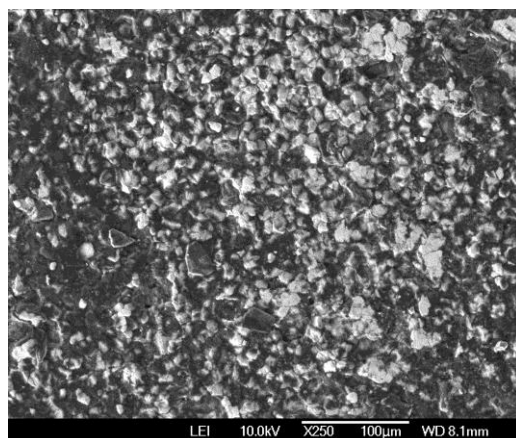
Fig 8: Magnified the non-contacted surface of the flexible female terminal in Fig. 6
