A Rare Malposition of Central Venous Catheter Inserted Through Internal Jugular Vein

Abstract: Central venous cannulation is routinely carried out by anaesthesiologist in ICU as well as OR setup. Definitely it requires expertise for proper placement of a CVC, but malposition of a CVC inserted by blind technique is not rare.

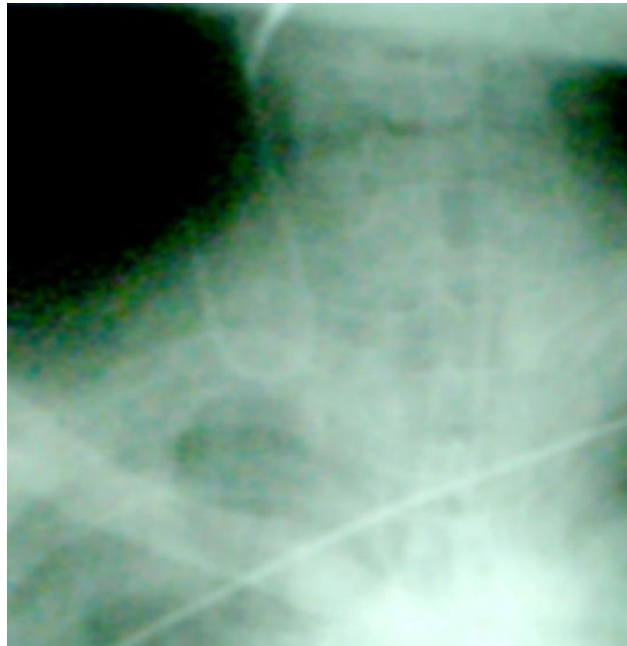
A check X-ray was performed [Figure-1] and it was found that CVC had taken a 180 degree turn and was suspected to have entered the external jugular vein (EJV) from IJV, probably through an anomalous communication between the two neck veins.

Figure-1: X-Ray showing malposition of central venous catheter

The migration of CVC on IJV insertion to EJV through anomalous connection is probably a rare event if not the first of its kind. This was surprising since the least resistant path could have been to brachiocephalic vein or to subclavian vein. Instead the guide wire took a U- turn via an anomalous communication and entered EJV.

The possibility that CVC has bent and remained in the IJV itself was ruled out by the fact that the distance between tip and main stem of the catheter on X-ray was found to be 4 cm while the usual internal diameter of IJV varies from 0.5 to 2.2 cm only. The CVC could not have entered in the EJV through the subclavian vein as EJV drains into subclavian vein behind the clavicular head of sternocleidomastoid muscle (SCM). In our case the U-turn of CVC had not reached the clavicle instead it was 6cm above the clavicle.
