Analysing Heritage Building Conservation Against Sustainability factors

Ahmed Gomaa¹

¹Department of Civil Engineering, Faculty of Engineering, Alexandria University, Egypt

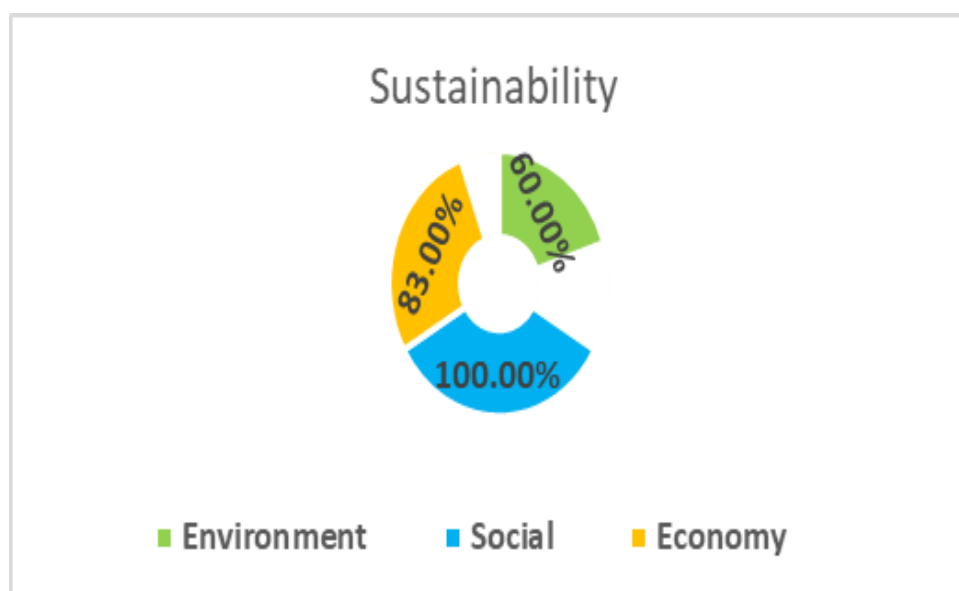
Examining the interaction of the three pillar factors shows a similarity to the previously concluded result, the analysis shows a full compliance with the social factors and similar value for the economic factor, however because of the nature of work done at the location and the orientation of the building within the city boundaries the Environmental factor showed some improvement resulted for the fuel low consumption which would positively affect the CO2 emissions Figure (4).

Figure 4: Case Study Sustainability Degree assessment of Heritage Building Conservation

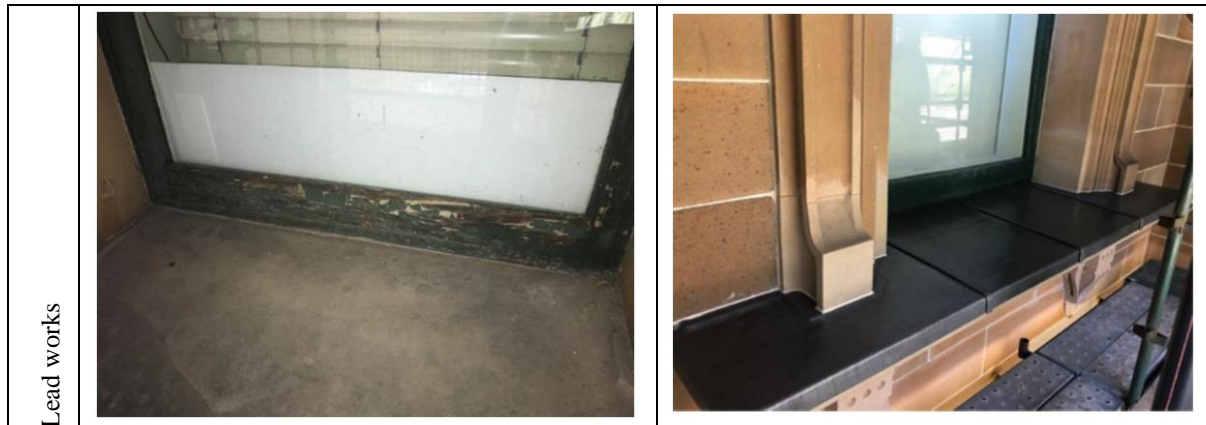
III.3.8 Photographic Record Sample

Cat	Before	After
Stone works	 	 
Repairs	 	 
Cleaning

- Stone Cleaning, Desalination and Biocide application
- Stone Replacement/Indents (total No. of 32 Stones)
- Synthetic Stone Repairs and repointing.
- Metal Vents, Timber frame painting and bird proofing
- Lead weathering
