STUDY ON LANDSLIDE DAMAGE IN KODAGU

Abstract: Natural hazards are repeated in Madikeri since 2018 that take place during monsoon and damage crops, livestock and settlements. Data on flood, drought, cyclone and waterlogging were collected. Heavy rainfall not only cause floods and debris flows, but also trigger off landslides on steep slopes. The danger due to these slope instabilities is considerably high, as they often evolve into debris flow that may damage cultivated land, buildings and infrastructures, and even cause fatalities. This paper discusses certain technical aspects of the landslides at various locations of kodagu district that triggered off by heavy rainfall in the season of July - August 2018. This article concentrates on the documentation and analysis of rainfall events, with a focus on evaluating the effects of urbanization on landslides. It summarizes the results of one landslide inventories after severe rainstorms in Kodagu during the previous month (August 2018), concentrating on the observations during field surveys and similarities between forest and open land.

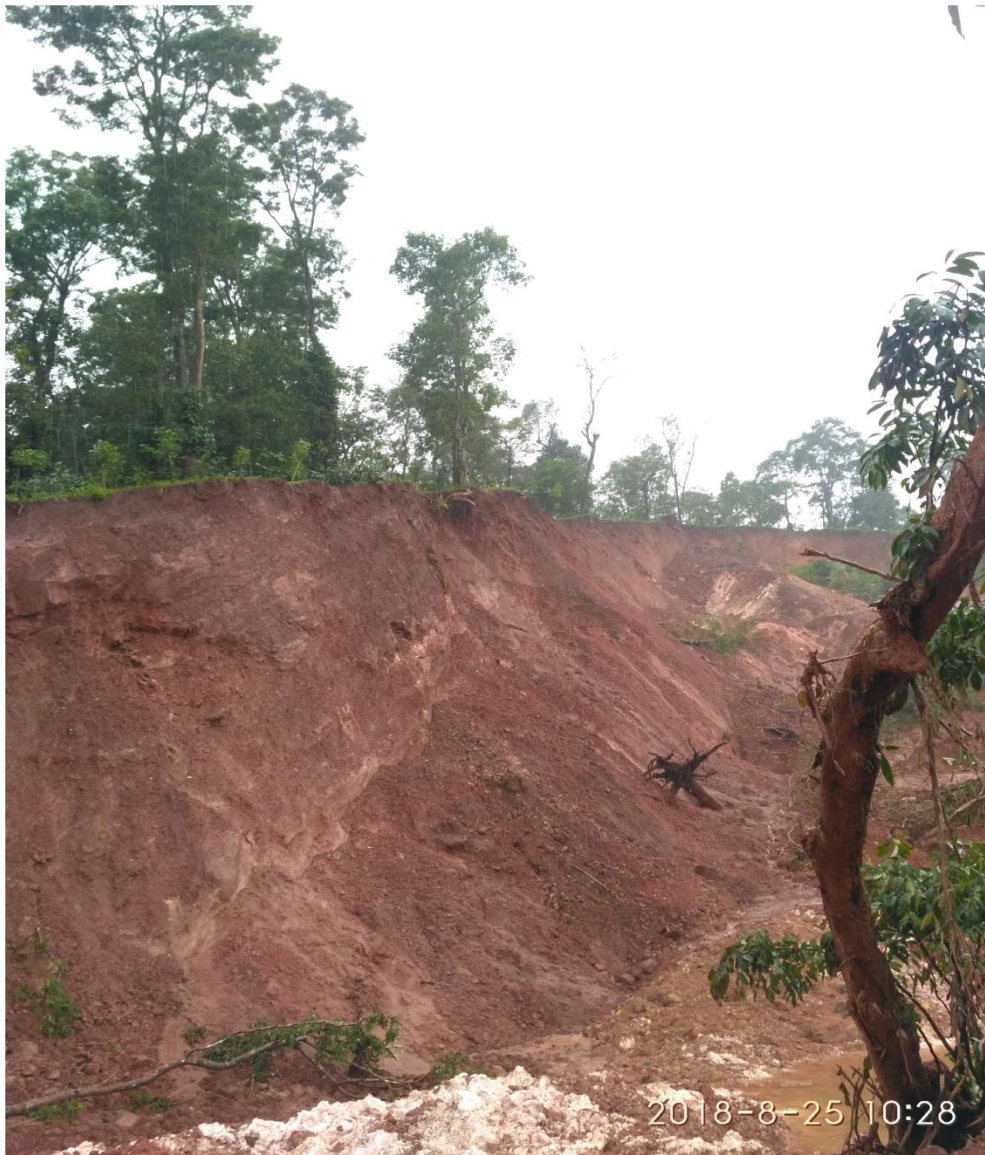
Fig. 2 Landslide Triggerred off by the August 2018 Rainfall Event in Hattihole Region, Kodagu

It is evident from Figure 2 that slope inclination is a crucial factor for slope stability. On slopes with an inclination of less than about 20° , the driving forces are normally low compared to soil strength. On slopes steeper than 45° , the landslide density decreases resulting in the dislodging of heavy mass (Residential Building) from its original position.

Information from the local public at flood rehabilitation centres of Suntikoppa area is used to locate the Hattihole landslide site which is as shown in Figure 2. The data from Indian meteorological department, Bengaluru showed that, Talacauvery received 375 mm of rainfall in 24 hours (from 8 a.m. on Monday 13-08-2018). This is said to be a record amount of rainfall on one day in the past few years. Somwarpet received 52 mm of rainfall, Madikeri 106.4 mm, Bhagamandala 113.2 mm and Virajpet 185.8 mm rainfall in 24 hours beginning 8 a.m. on Monday (13-08-2018). In the corresponding period last year (2017), Somwarpet had not received any rain while Madikeri had received 1.5 mm, Bhagamandala 17.6 mm and Virajpet 12.2 mm. The precipitation data showed that 45% (768mm) of the August rainfall was received within three days i.e., August 15, 16, 17. Such a high quantum of rain within a short duration of 72 hours could be the reason for heavy landslides in the history of Kodagu district. During heavy rains, when underground water percolates the sloping layers, it might have resulted in erosion of soluble mineral salts in the rock mass, thereby creating fissures and fractures inside the sloping ground that disturbs the strength of the slopes, resulting in landslides.

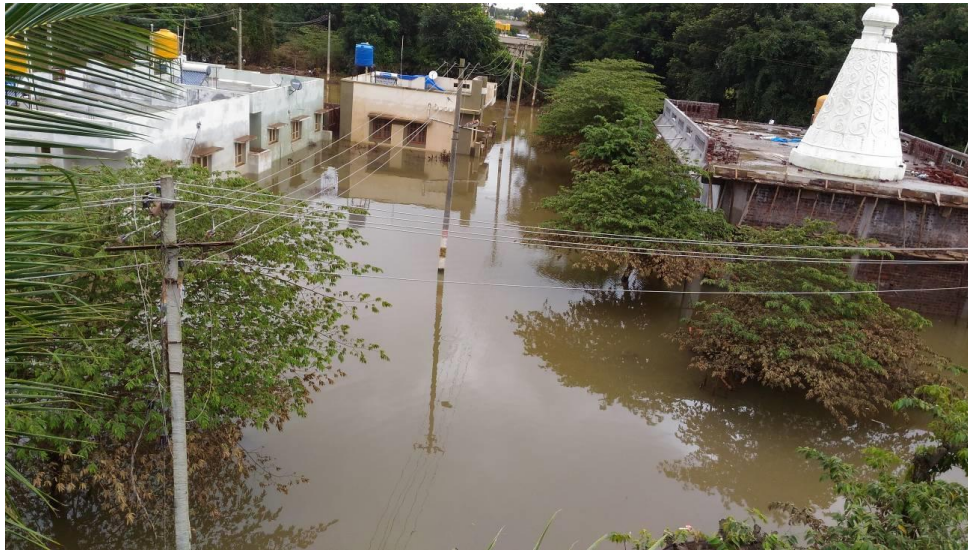
Fig.3: Image of the flooded area at Sai Layout, Kushalanagara.

Due to this heavy rains, and high rate of inflow to the Harangi dam, Around 40,000 cusecs of water was discharged from the Harangi dam resulting in submerging Some localities (Sai Layout, Kuvempu Layout and Kariappa Badavane) in Kushalnagara town which were flooded as shown in Figure 4. This is due to the fact that these layouts were existing very close to the river Cauvery.
