Study of the Effect of Seawater on Fiber Bars Used to Reinforce Concrete Slabs When Exposed to High Temperatures

Abstract: The main objective of this study is to know the effect of sea water and high temperature on the rods made of fiberglass, Experimental work Three concrete slabs were made, mixed with different percentages of seawater 0%, 50% and 100%, and fiber bars were used to reinforce these samples The length of the fiber rod was 160 cm with a diameter of 12 mm, and 12 rods were placed in each direction to be in the form of a net in the sample. These samples were exposed to a temperature of 300 degrees and the exposure time was 60 minutes.

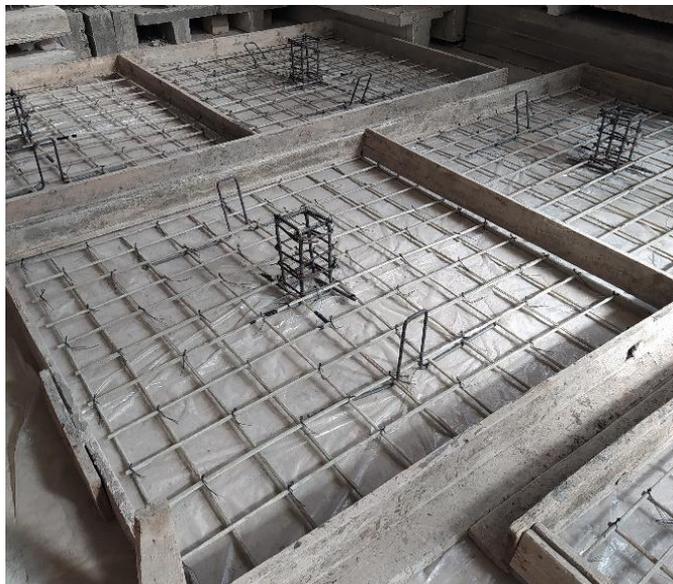
Fig 1: wooden intensity

Three R.C. slabs with cross-section, sized 1650 mm (width) x 150 mm (height) x 1650 mm length, were manufactured and tested as shown in Fig (1) reinforcement network Fig (2).

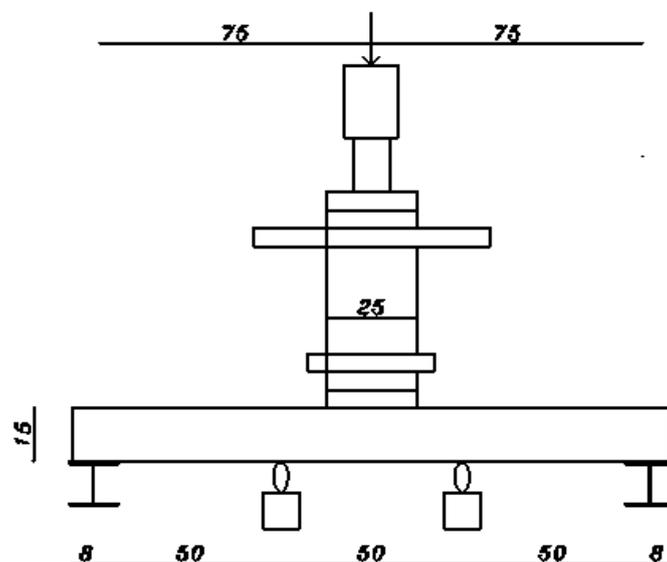
Fig 2: The furnace used in the fire

The test was carried out in two stages. The first stage is that the sample is placed on the specialized device and the sample is exposed to fire as shown Fig. (3). Then the sample is left to cool in the air. Then the loading test is done by means of a hydraulic arm.

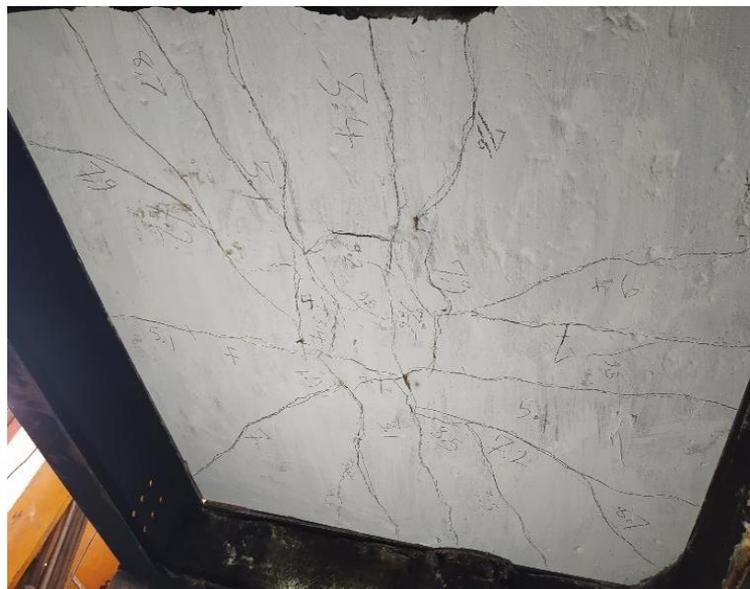
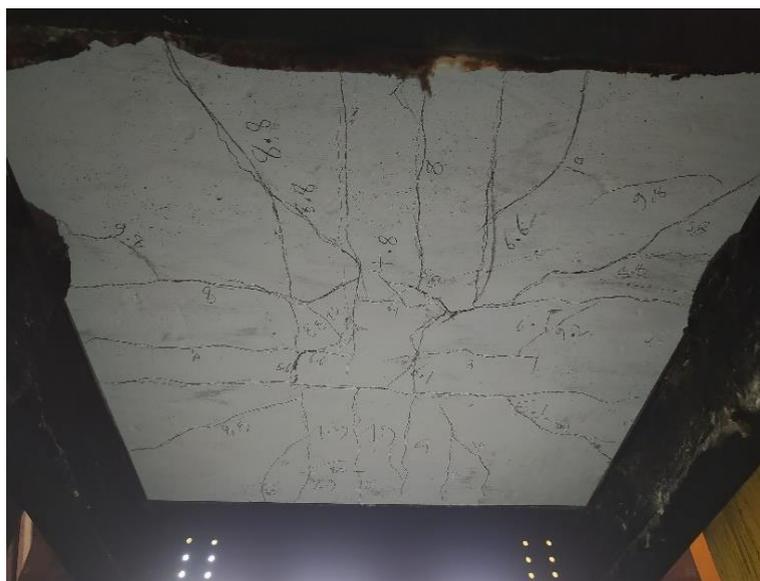
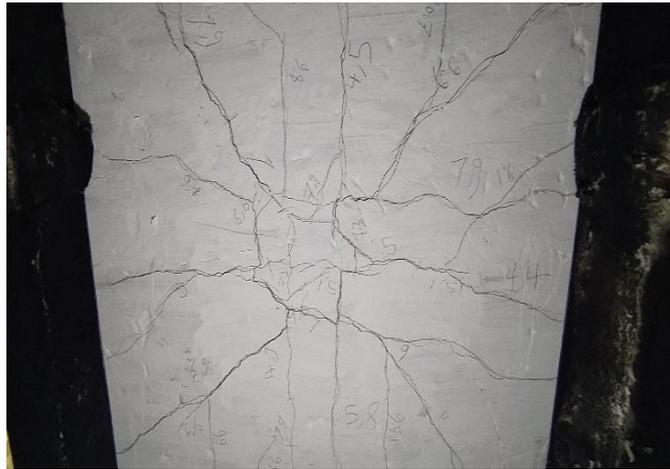
The crack pattern is as shown in Fig 4, where the shape of the collapse was clearly a piercing shear collapse, for each of the three samples. With the increase in the percentage of sea water in the sample, the number of cracks in the samples increased in the tension area where the fiber rods are located, and the high temperature was not effect on the shape of cracks, nor on the final collapse pattern.

Fig 3a (s1 – 0)

Fig 4b (s2- 50)

Fig 4c (s3 – 100)

- 1-The effect of temperature on the bonding between the fiber bars and the concrete was noticeable by changing the shape of the fracture in some parts to be parallel to the reinforcing bars.
- 2-The exposure of the bars made of fiberglass to heat, and sea water led to a decrease in the tensile strength of the bars
- 3-The use of fiber bars with temperatures affects the amount of emotion that occurs to the bars

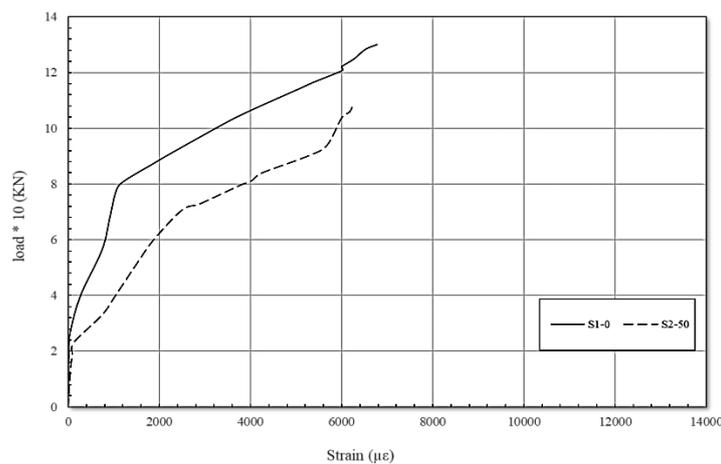
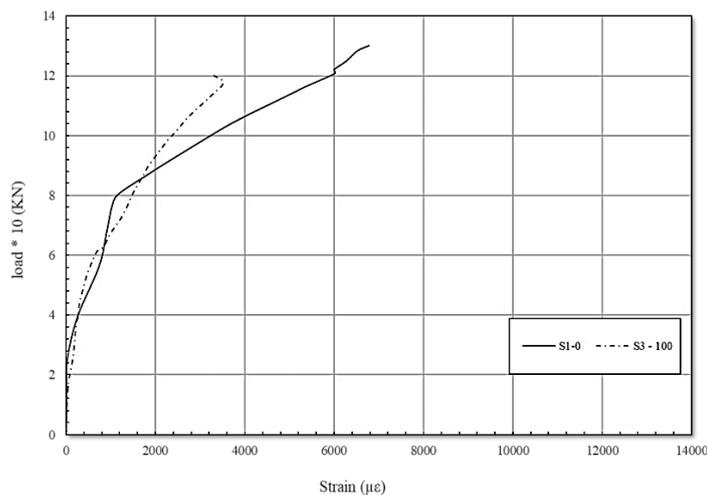
The axial strains of the tension reinforcement were measured at specific points on the bottom mesh at different locations using electrical strain gages. The data was recorded using data acquisition system. The typical locations of the strain gauges on the bottom reinforcement for the specimens, the vertical load was depicted against the axial strain for the specimen S1-0, S2-50, and S3-100 respectively as shown Fig 5. From the fig, the increase in the percentage of seawater and the temperature affects the properties of the fiber BARs and the way they work.

Fig 4a load-strain curve

Fig 5b load-strain curve

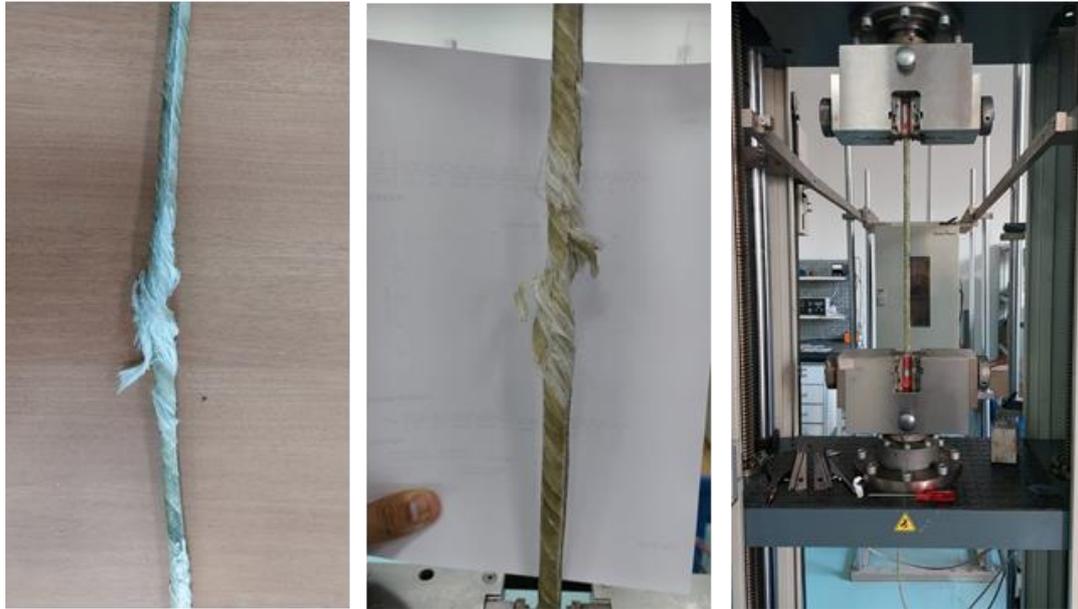
Fig 5 tensile test

A tensile test was conducted on the sample of the bars before exposure to seawater and fire. A sample of the fiber bars were extracted from the slabs and a tensile test was carried out on it, where an iron pipe was placed at both ends of the bar so that the tip of the bar would not collapse in the dismantling of the machine. As shown fig 6 After the fiber bars were exposed to fire and sea water, this led to a decrease in the tensile strength and a collapse form in the bar
