# Increasing Incidences of Cloudburst Triggered Debris-Flows/Flash Floods in Garhwal Himalaya, India

**Abstract:** This study examines the increasing incidences of cloudburst triggered debris-flows/flash floods in the Garhwal Himalaya, India. Data were gathered through the case studies of three incidences that occurred during the monsoon season – July, August, and September 2019. A total of 24 people died and 39 people were injured due to the cloudburst triggered debris-flows and flash floods events during the period. Further, about 150 roads were blocked and several houses, cowsheds, and agricultural land were drowned during the same time. This study reveals that most of the death and loss of property occurred along the river valleys because of the construction of houses on the fragile landscapes of these rivers' banks. This study suggests that the construction of settlements should be avoided along the river valleys or on fragile landscapes. Economic activities should also be avoided in these fragile locations.

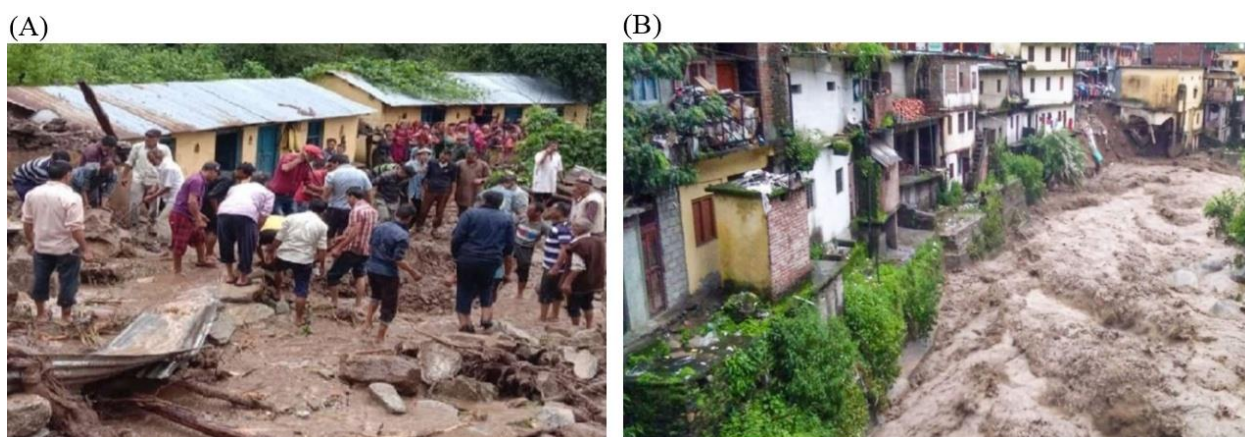
**Figure 4 (A) Debris flow in the Faldia village, Deval and (B) Flash flood in the old Ghat town, Chamoli district; Photo By author**

In the months of July, August, and September 2019, the entire district received a number of cloudbursts events, which has resulted in a huge loss of lives and property, including infrastructure, human habitats and agricultural fields. Table 1 shows cloudbursts triggered debris flows and flash floods in several locations of the district. On August 8, 2019, debris flow, which was triggered by a cloudburst, devastated the Faldia village, lies in the Deval block in the right bank of the Pindar River (Figure 4 A). Due to debris flow, two women have died and 18 animals were drowned. A total of 12 houses and eight cowsheds were fully damaged. In terms of infrastructural facilities, three bridges were collapsed and drowned and a large proportion of agricultural land (four ha) was washed away. On the same day (i.e. August 8, 2019), cloudburst triggered debris flow occurred in the Mainthana village, which lies on the way to the Badrinath pilgrimage near Langasu in Chamoli district. As a consequence of the incident, two houses were collapsed and a large proportion of arable land was washed away.

One of the biggest incidences occurred in the Nandakini River valley in Ghat development block of the Chamoli District on August 12, 2019. Cloudburst triggered a flash flood that occurred in the Chufalgarh, a tributary of the Nandakini River, which has fully affected the Banjbagar, Lankhi, and Ali villages. Old Bazar of Ghat (Figure 4 B), which is located on the left bank of Chufalgarh, was largely damaged. Due to flash floods, six people have died and 40 animals were drowned. In

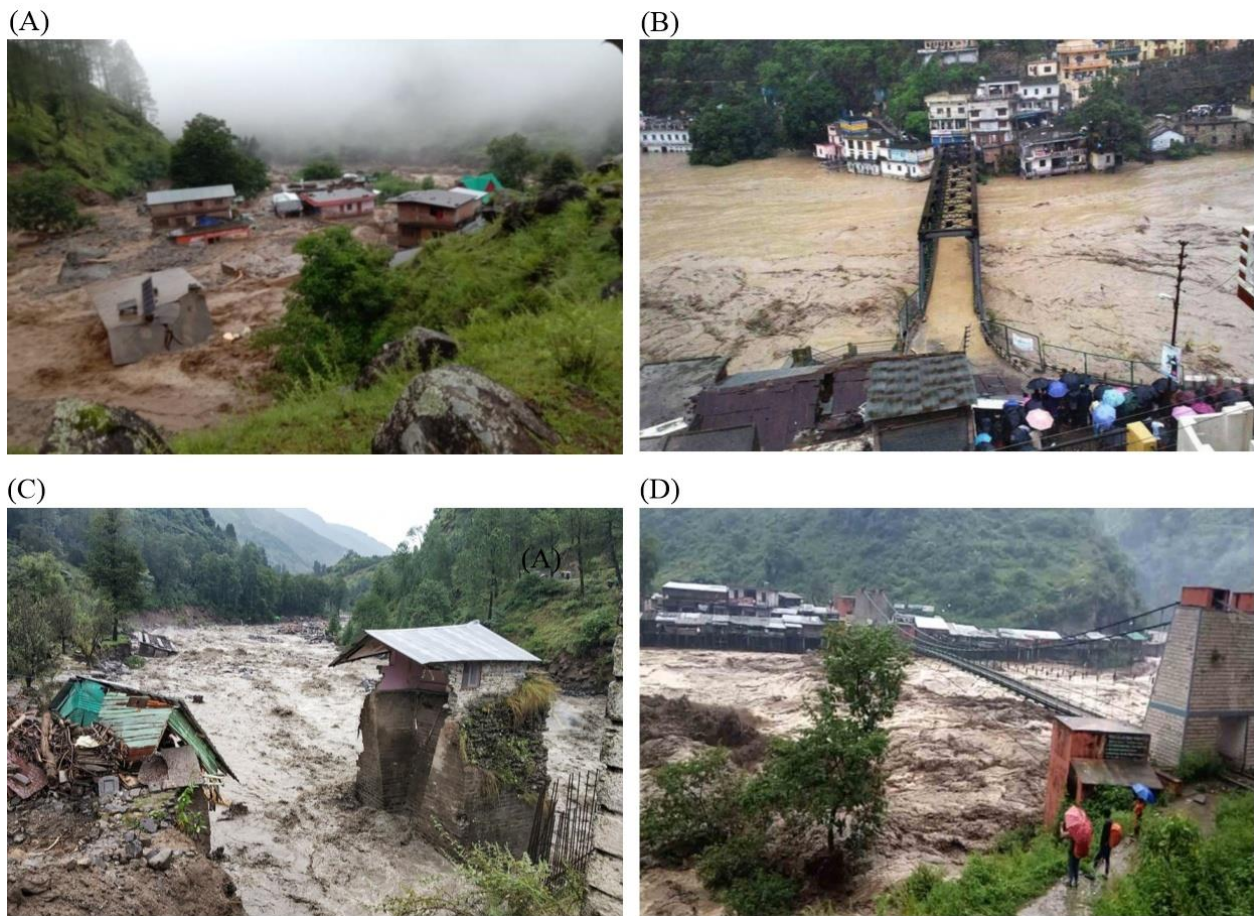
**Figure 5 (A) Tikochi Bazar fully collapsed due to flash flood in the Pawar River (B) Flash flood in the Pawar River in Arakot market Uttarkashi (C) The Pawar River near Arakot (D) Ton River overflows above danger mark in Mori, Uttarkashi; Photo By author**

On the night of 13<sup>th</sup> and 14<sup>th</sup> August 2019, several incidences occurred in the Mori block of the Uttarkashi district. The Tons River flew over the danger mark (Figure 5 B and D). Due to this incident, 19 people were killed, nine were missing, and 47000 people of the 50 villages were affected. A heavy loss of property took place and a large portion of agricultural land was washed away. On August 17, 2019, five people died and a crusher machine was drowned due to debris flow in the Sanel village. Another big disaster of flash flood/debris flow occurred in Arakot market, Mori block, which has caused the killing of 11 people, missing seven and injuring seven people (Figure 5 A and C).
