Effect of SHEAR SPAN-TO DEPTH RATIO of Concrete Beams Reinforced with GFRP bars on Shear under fire Exposure

M. A. OSMAN¹, Hala Mamdoh², Ahmed H. Ali³, Hamdy. M. Mohamed⁴, and T.S.kamal⁵

Keywords: Shear span, Concrete Beams, Depth ratio, GFRP bars.

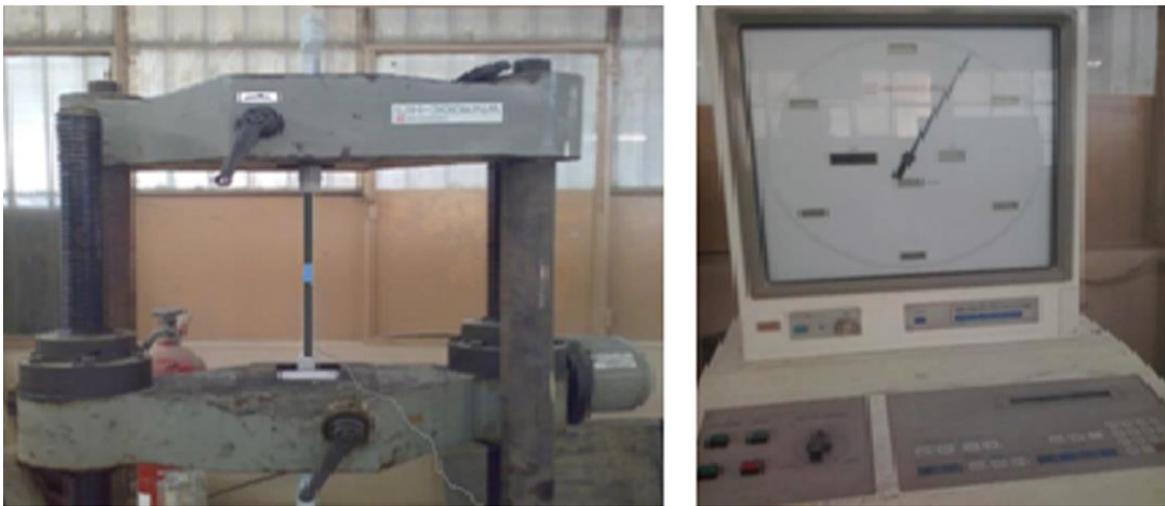
Fig.1. Shimadzu Machine.

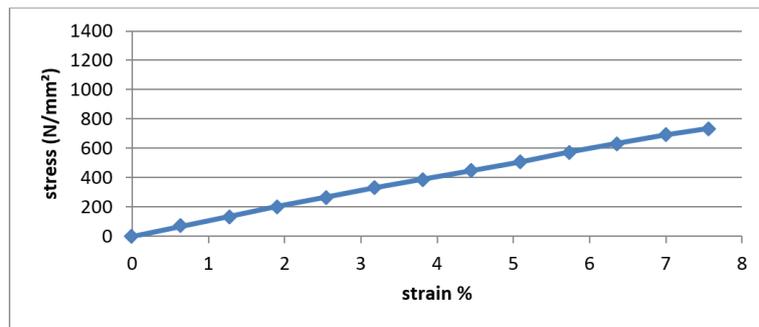
Fig. 2. Stress-Strain Curve for Glass Bar

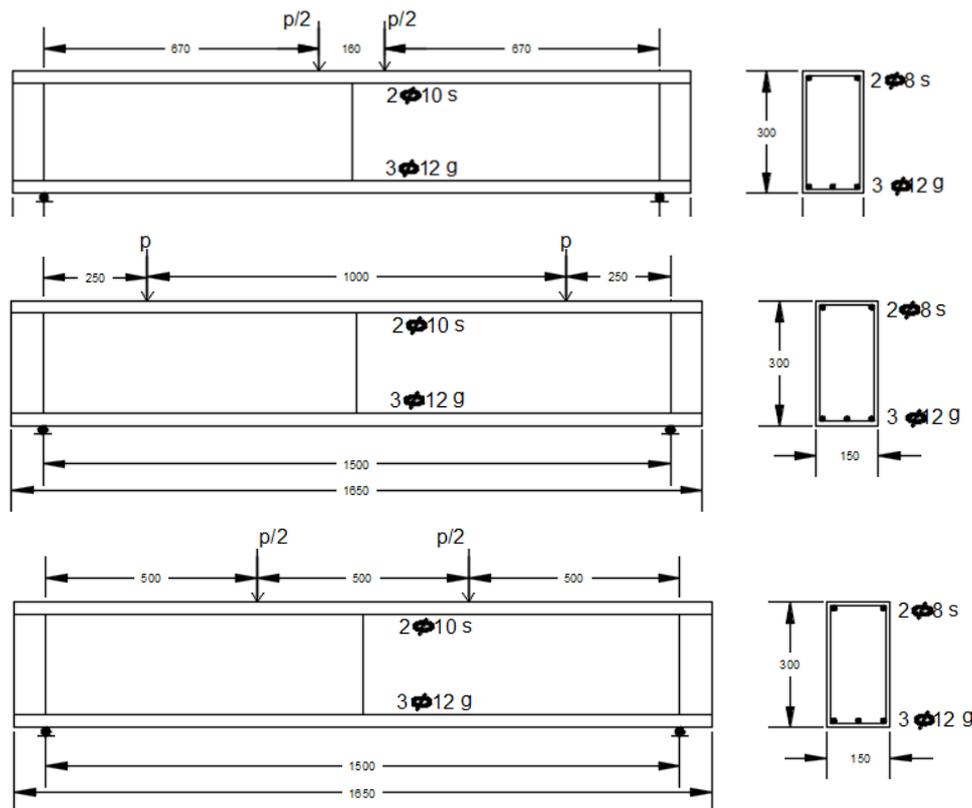
Fig. 3. Details of Tested Beams.

Three reinforced concrete beam specimens measuring 150 mm × 300 mm were tested in this study, with a total span of 1650 mm. beams were constructed and tested up to failure under direct fire at 500 °C for an hour. Beam (B1) had distance from face of support 670 mm ,beam (B2) had distance from face of support 250 mm and beam (B3) had distance from face of support 500 mm .All beams had 30 mm concrete cover , exposed to fire for an hour and three GFRPs reinforcement bars were used, as shown in Table 2. For the top reinforcement, two 8-mm steel bars for the top reinforcement and three 12-mm GFRPs bars for the bottom reinforcement. The details of the reinforcement and the cross-section of the tested beams are illustrated in Fig. 3. Reinforcement cages were prepared and thirteen clean smooth wooden forms were used for casting all the test specimens as shown in Fig. 4. All beam specimens were cured regularly by a sprinkling of water and covered by sackcloth to prevent moisture release from the concrete surface until the date of testing. Cubes were curing by immersing them in water.

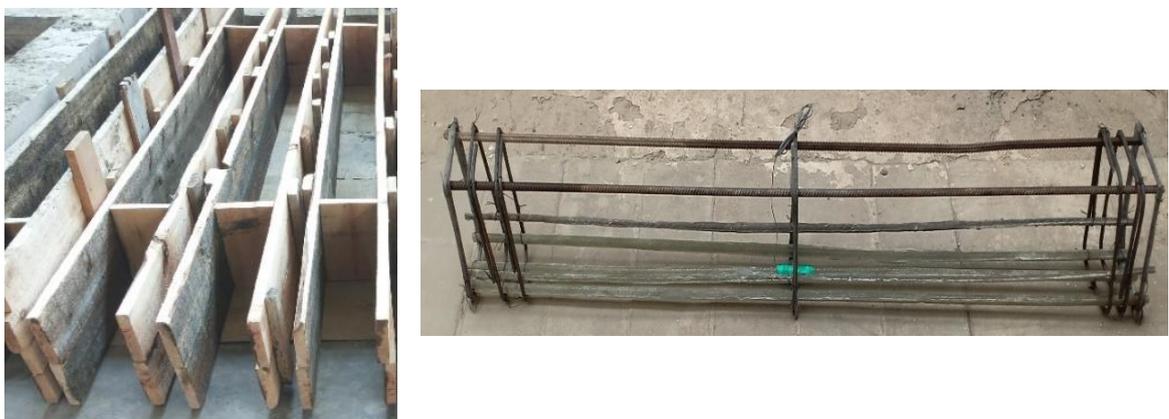
Fig. 4. Details of Reinforcement and Wooden Forms.

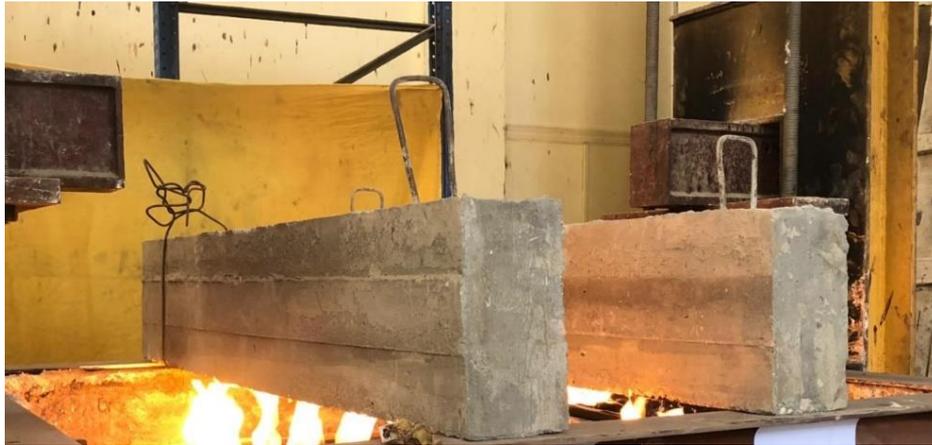
Fig. 5. Beams subjected to Fire.

A steel furnace with seven burners lined parallel to each other was used with dimension 2000 mm × 2000 mm × 600 mm; the furnace was heated to the required temperature, i.e. (500 °C) and then kept at this temperature for an hour. The beams subjected to direct fire are shown in Fig. 5. The used regime for cooling the fire beams was air.

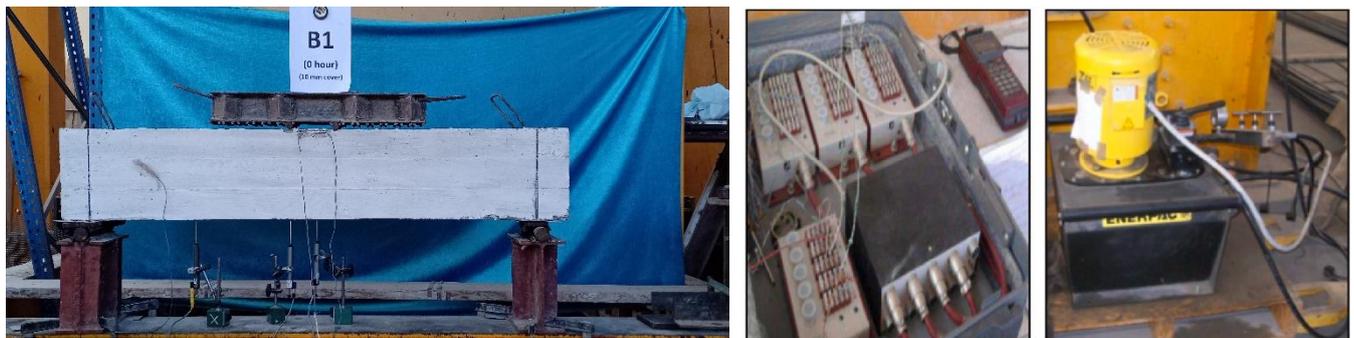
Fig. 6. Experimental Test Setup, Load Cell, and Data Logger and Reader.

All the beam specimens were subjected to two-point loading under an incremental force control which increased by 2kN per grade until cracks appearing, and then 4kN per grade up to the failure load. During the loading tests, load cells were used to measure the applied load, three linear variable differential transducers (LVDT) were used to measure the deflection (the first one at mid-span, the second under loading point and the third mid between loading point and support, sensors were used to prevent damage during the tests, electrical strain gauges (60 mm length) were attached to measure the concrete strain. The strain gauges were fixed on the at top surfaces of the mid span. The digital load cell of capacity 550kN was adopted to measure the applied load, the load increments, and the displacements were read directly from the data recorder. The crack growth of the specimens during loading and at the time of failure was observed. The test setup and instrumentation are illustrated in Fig. 6.

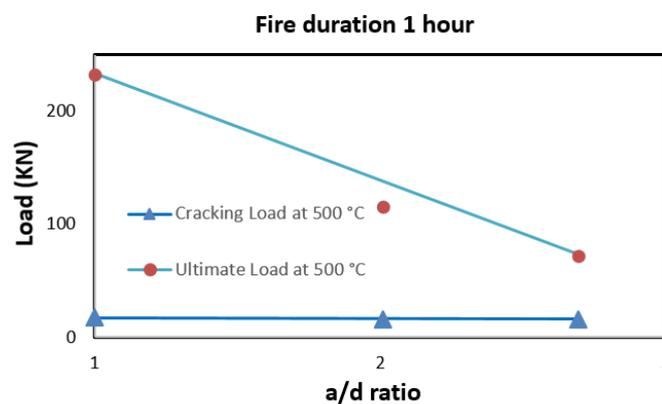
Fig. 7. Effect a/d ratio on Cracking and Failure load.

Table 3 shows the results of all tested beams, including the cracking load and its corresponding deflections (P_{cr} and Δ_{cr}) as well as the ultimate load and its corresponding deflection (P_f and Δ_f). Furthermore, the failure patterns of the GFRP tested beams were observed. Fig. 7 illustrates the effect a/d ratio on the cracking and ultimate loads for all specimens at 500 °C. Overall, the quick glance of Table 3 and Fig. 7 reveal that there is a direct relation between a/d ratio and corresponding load capacity values at 500 °C for an hour. Turning to details, when distance from face of support over effective depth greater than 2.5 the beams act as slender beams while distance from face of support over effective depth less than 2.5 the beams act as arch action. Our results also showed that when distance from face of support over effective

depth 2.02 the failure load increase by percent 60.3% and beam failure as shear failure while distance from face of support over effective depth 1.01 the failure load increase by percent 221.7% and beam failure as flexural failure.

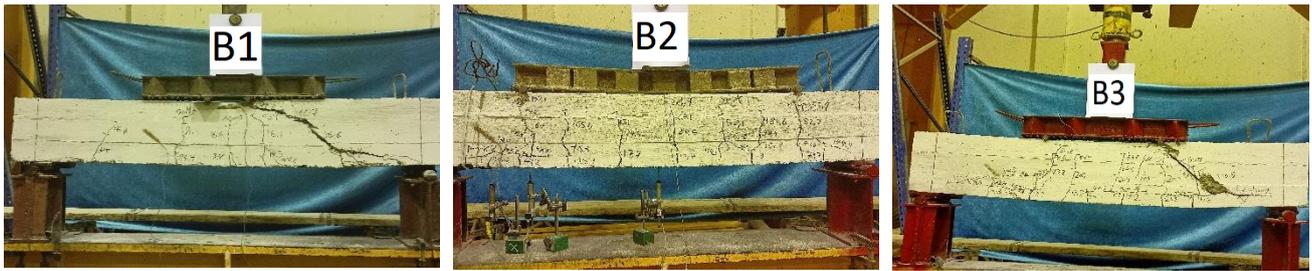
Fig. 8. Crack pattern and Failure Mode of Tested Beams.

Fig. 8 shows the crack development and failure type for all tested beams. The crack patterns at both faces of all beams were recorded at several load stages up to failure. Comparing the load patterns at both faces revealed that both patterns are largely similar. The specimen remained with no visible cracks until flexural cracking took place. Flexural cracking at first took place at mid-span of the tested beams then flexure-shear cracking and flexural cracking extended over the beam. As loading increased, more flexural and diagonal cracks were formed and cracks became wider. As clearly, the failure mode depend on a/d ratio. Due to fire exposure, wider and fewer flexural cracks developed, owing to the reduced strength of concrete and the susceptibility of the resin on the surface of the GFRPs to soften, thereby resulting in a lower bond between reinforcement and surrounding concrete [13], concrete in the compression zone crushed and the concrete cover spalled, the concrete spalling behaviour occurs in the condition of fire due to the low permeability of concrete, which limits the ability of water vapor to escape from the pores, this results in inducing internal pore pressure and thermal stresses [14].

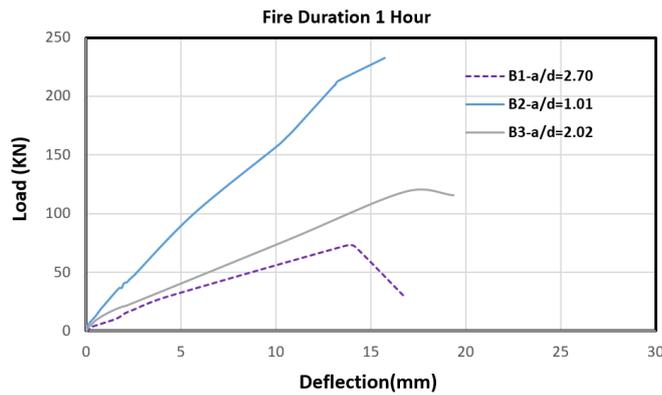
Fig. 9: Load-Deflection Curves at Mid Span for Beams Tested.

Fig. 9 shows the relationship between the applied load and mid-span deflection for the studied beams, most of the tested beams failed in a ductile manner with large mid-span deflection thus absorbing more energy during failure. The deflections of all beams increased uniformly during loading. As shown, the behaviour of the load–deflection curve of the GFRP reinforced beam was linear before cracking and slightly nonlinear up to failure with lack of yielding. the GFRPs beams with a/d 2.02 the increase percentage in deflection 15.25%, while the GFRPs beams with a/d 1.01 the increase percentage in deflection 35.4%. The increased deflection will lead to extensive cracking along the length of the beam, thereby significantly reducing its flexural and shear stiffness. So the stiffness of the GFRP RC beam obviously decreased after cracking. The effect of high temperatures was evident from the continuous decrease in the load capacity of the beams.

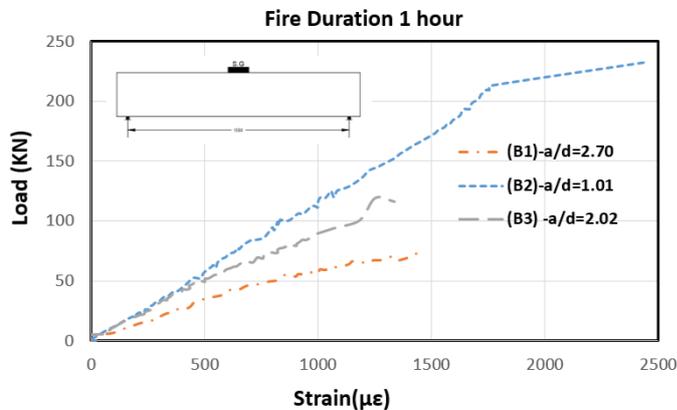
Fig. 10. Load-strain relationship for the concrete at top compression zone.

The relation between the concrete at compression zone and the applied load is shown in Figure (10). The strain gauge located at top surfaces of the mid span.
